Ankle Plating System 3 and Fibula Nail 2 System

Lateral Malleolar Revision and Trimalleolar Fracture Fixation

Case Study | Gerard J. Cush, MD

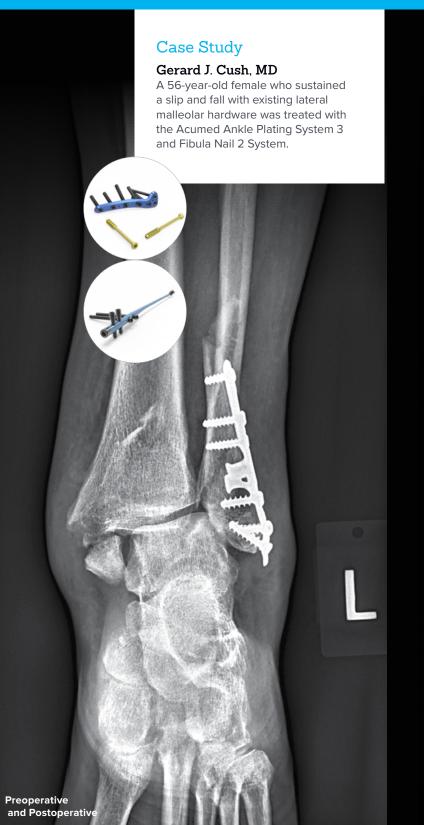
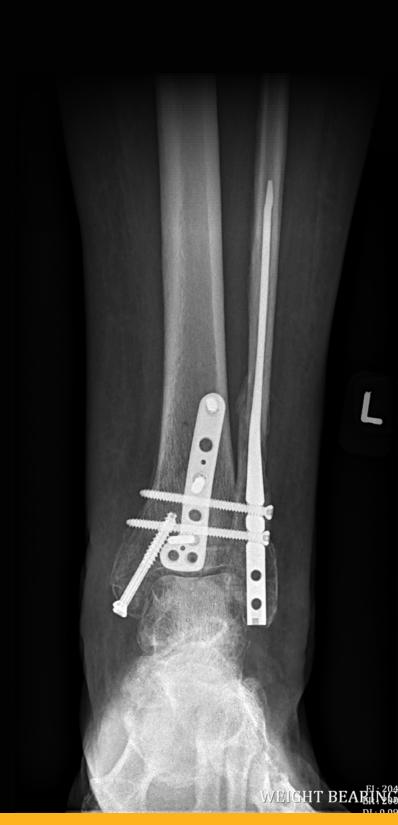
A 56- year-old female, with a medical history of hyperlipidemia and previous open reduction and fixation of lateral malleolar fracture, sustained a trimalleolar ankle fracture dislocation above previous hardware (Figure 1 and 2).
